**Flood Control Project Maintenance
Levee Inspections****LMA District Cover Sheet****Spring 2014 Levee Inspection Results****Sutter Maintenance Yard East Levee Sacramento River**

Spring 2014 Levee Inspection Results

Sutter Maintenance Yard East Levee Sacramento River

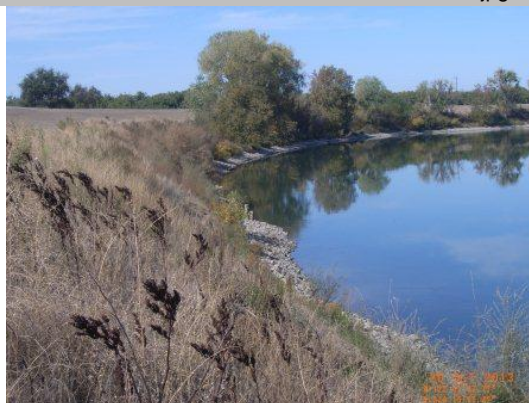
Photo 1 of 1 : USACE2013A_SAC_151-0_R_6.jpg

LM Start	0.00	Rating **	M	Issue No.	27
LM End	11.41	Issue Type +	Ma	Location *	WS
Category	Supplemental			GPS Latitude/Longitude	
				Start	End
Item	USACE Erosion Survey			39.266315 °	39.265730 °
				-122.020682 °	-122.014925 °
DWR ID					
Action/Comments					
Inspector Comments: 2009 - Slump in the middle of the section has left a vertical section on the bank. 2010 - Old cobble site unraveling, site extended downstream. 2013: No observed changes. [2013 Site ID: SAC_151-0_R]

USACE 2013 Photo #1

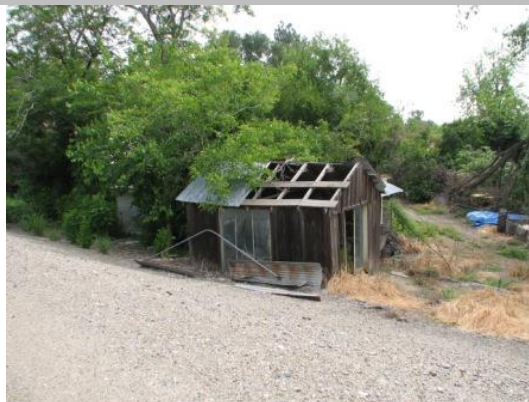
Photo 1 of 1 : rduffey_s_20140304_646.jpg

LM Start	0.08	Rating **	U	Issue No.	3
LM End	0.14	Issue Type +	En	Location *	WS
Category	Earthen Levee			GPS Latitude/Longitude	
				Start	End
Item	Encroachments			39.194978 °	39.195022 °
				-121.937502 °	-121.938563 °
DWR ID	DWR_ST0003_01_s_2012_3				
Action/Comments					
Building

View of a old building next to the landside toe.

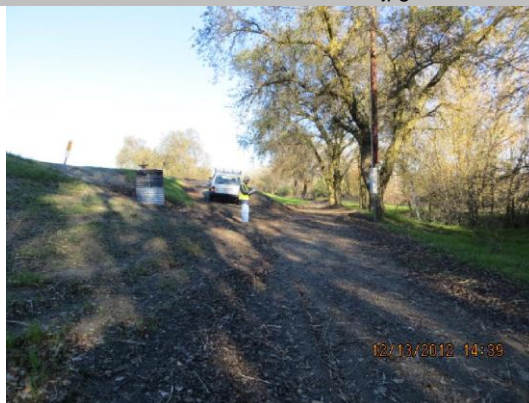
Photo 1 of 1 : UCIP_5066.jpg

LM Start	1.11	Rating **	M	Issue No.	8
LM End	1.11	Issue Type +	En	Location *	LS
Category	Supplemental			GPS Latitude/Longitude	
				Start	End
Item	DWR UCIP Field Study			39.194106 °	39.194106 °
				-121.953512 °	-121.953512 °
DWR ID	DWR_ST0003_01_s _ 2014_8				
Action/Comments					
Inspector Comments: FS_ID:26125					
EP_NO: 9527					
Repair Type:					
Crossing Status:					
UCIP Comments: Abandoned and plugged/capped steel pipe on WS berm. DWR leaky pipe marker on LS (12-3). Slope failure on LS. Needs capping of LS steel pipe after detailed investigation 7/29/2013 Pipe does not appear to be abandoned. On the WS it appears that a smaller pipe was sleeved into the 18in. pipe and then the difference capped and welded. Pump was not running at time of inspection but LS ditch near outlet was wet. LS slope damage and leaky pipe marker are still present 2/30/2013 Same as last inspection.					
FIELD_STRUCT_DESC: 18-inch steel pipe through the levee 12.5 feet below the crown. Gate valve on the waterward side. Vertical pump on the bank. (ABO No. 9527 - Butte Creek Farms). O&M manual 136, revision May 2011

Waterside view: overview

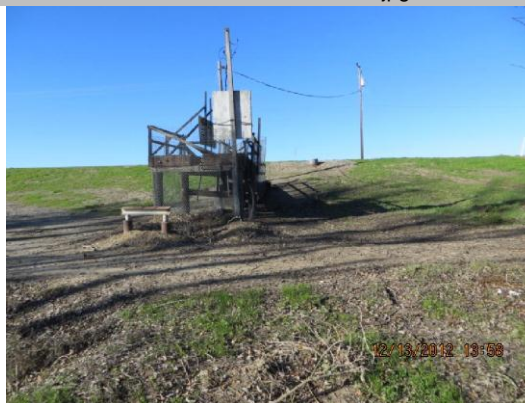
Photo 1 of 1 : UCIP_5074.jpg

UCIP Comments: Sloughing LS slope and river bank. DWR marking for leaky pipe 7/29/2013 Same as last inspection 12/30/2013 Same as last inspection.

Waterside view: abandoned pump station.

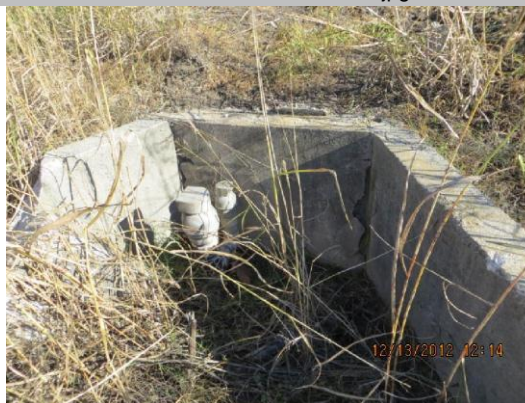
Photo 1 of 1 : UCIP_5085.jpg

Action/Comments					
Inspector Comments: FS_ID:26146					
EP_NO: 9539					
Repair Type:					
Crossing Status:					
UCIP Comments: - it seems that the system was originally designed for drainage, later converted into irrigation system: 6-inch GI pipe and 18-inch PVC pipes inserted into culvert from LS (not plugged)WS opening is plugged with concrete,probably pump is located 350 ft from levee as seen from Google Earth Map/29/2013 Same as last inspection12/30/2013 Same as last inspection.					
FIELD_STRUCT_DESC: A 30-inch by 36-inch concrete culvert drain through the levee. Gates with 2-inch flashboards on the waterward end. 18-inch PVC pipe through culvert. 13.6 ft invert below crown. (ABO No. 9539 - Locvich). O&M manual 136, revision May 2011					
FS Date: 1/2/2014 8:05:57 AM

Waterside view: plugged concrete structure and siphon breakers

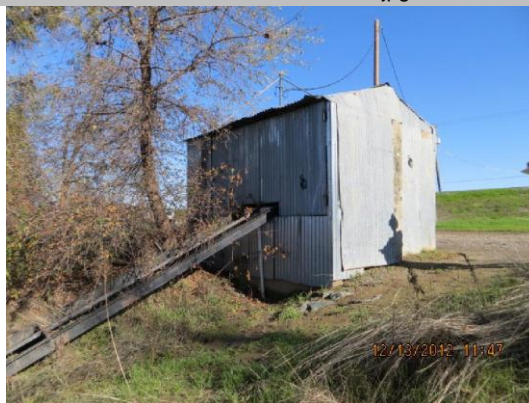
Photo 1 of 1 : UCIP_5272.jpg

LM Start	3.79	Rating **	M	Issue No.	24
LM End	3.79	Issue Type +	En	Location *	LS
Category	Supplemental			GPS Latitude/Longitude	
				Start	End
Item	DWR UCIP Field Study			39.204141 °	39.204141 °
				-121.982698 °	-121.982698 °
DWR ID	DWR_ST0003_01_s _ 2014_24				
Action/Comments					
Inspector Comments: FS_ID:26395					
EP_NO: 9501					
Repair Type:					
Crossing Status:					
UCIP Comments: Concrete pit on WS berm. Concrete distribution box on LS silted and erosion around the box. Slope failure/ transverse cracks on LS levee slope. Two depressions on WS berm. 7/29/2013 Repairs to LS slope and pipe are in progress. Nothing has been done yet to the WS depression. 12/30/2013 Repairs to LS and WS slopes have been completed. Not sure if this is an active or abandoned crossing. LS distribution box is still slited in.					
FIELD_STRUCT_DESC: 16-inch steel pipe through the levee with pump house over concrete pit on berm. No control valves visible. Discharges into concrete box at the landward toe. (ABO No. 9501 - Mayfair Farms). According to Permit 9501A, it is an existing abandoned pipe located at HLM 4.37.

Waterside view: overview of pipe and pump house

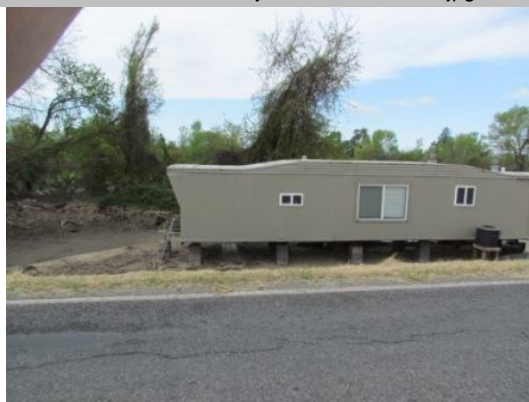
Photo 1 of 1 : rduffey_s_20140304_648.jpg

LM Start	4.19	Rating **	M	Issue No.	11
LM End	4.19	Issue Type +	En	Location *	WS
Category	Earthen Levee			GPS Latitude/Longitude	
				Start	End
Item	Encroachments			39.208935 °	39.208935 °
				-121.985310 °	-121.985310 °
DWR ID	DWR_ST0003_01_s _ 2012_11				
Action/Comments					
Building

View of the trailer next to the W/S toe.

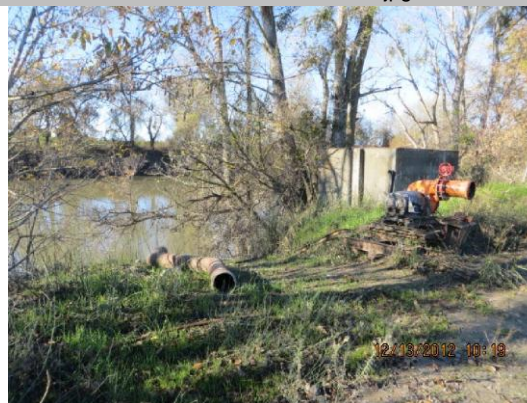
Photo 1 of 1 : UCIP_5089.jpg

LM Start	4.38	Rating **	M	Issue No.	26
LM End	4.38	Issue Type +	En	Location *	WS
Category	Supplemental			GPS Latitude/Longitude	
				Start	End
Item	DWR UCIP Field Study			39.210247 °	39.210247 °
				-121.988238 °	-121.988238 °
DWR ID	DWR_ST0003_01_s _ 2014_26				
Action/Comments					
Inspector Comments: FS_ID:26155					
EP_NO: 9501A					
Repair Type:					
Crossing Status:					
UCIP Comments: Motor and pump on berm. Appears an abandoned crossing. Leaky valve on LS slope. Pipe removed and laying on berm. No electric connection to the pump. 7/29/2013 Not an abandoned crossing. Pump is connected to WS pipe end at water level and is pumping water to LS and then goes underground to an irrigation ditch about 100yds. upstream. Pump and pipes are disconnected and pulled up to WS toe for high water season. Leaky valve on LS shoulder does not appear to have been fixed 2/30/2013 Same as last inspection. FIELD_STRUCT_DESC: Abandoned 10-inch diameter asphalt coated steel pipe through the levee 5 feet below the crown. Siphon breaker on the landward shoulder. (ABO No. 9501A - Mayfair Packing).

Waterside view: overview of pump and abandoned pipe

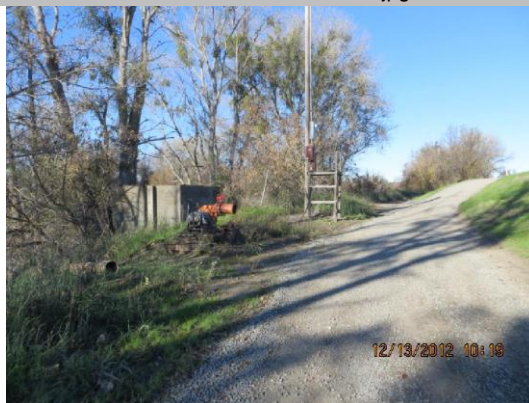
Photo 1 of 1 : UCIP_5101.jpg

UCIP Comments: Need to be properly abandoned. Transverse cracks on levee road. Also found a concrete outlet on LS. It is not clear whether this passes through the levee. 7/29/2013 Same as last inspection. 12/30/2013 Same as last inspection.

Waterside view: overview

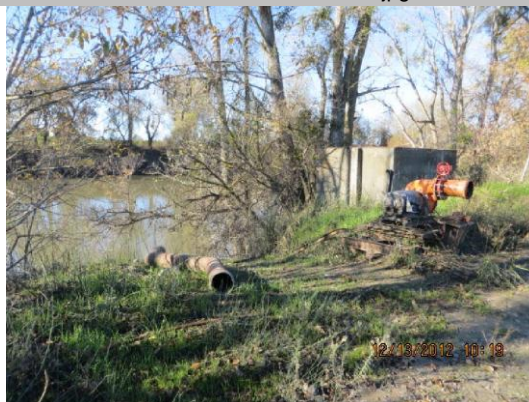
Photo 1 of 1 : UCIP_5108.jpg

LM Start	4.39	Rating **	M	Issue No.	37
LM End	4.39	Issue Type +	En	Location *	WS
Category	Supplemental			GPS Latitude/Longitude	
				Start	End
Item	DWR UCIP Field Study			39.210280 °	39.210280 °
				-121.988284 °	-121.988284 °
DWR ID	DWR_ST0003_01 s _ 2014_37

UCIP Comments: Debris and deteriorated concrete. Gate valve in surge tank. 7/29/2013 Same as last inspection. 12/30/2013 Same as last inspection.

Waterside view: overview of concrete surge box

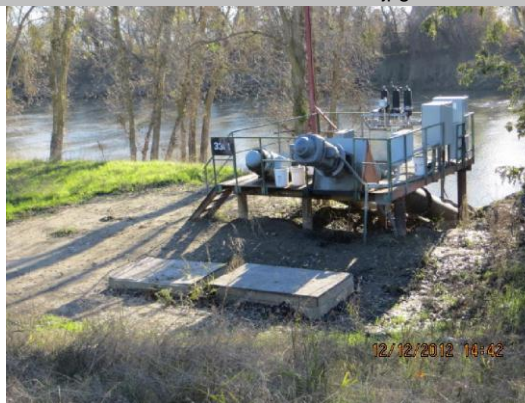
Photo 1 of 1 : UCIP_5113.jpg

UCIP Comments: Found a siphon breaker on LS. Antenna and pump station on WS. Huge erosion on LS slope 7/29/2013 Erosion near LS shoulder may start affecting the roadway if it gets any worse 2/30/2013 Same as last inspection.

Waterside view: overview of pump station

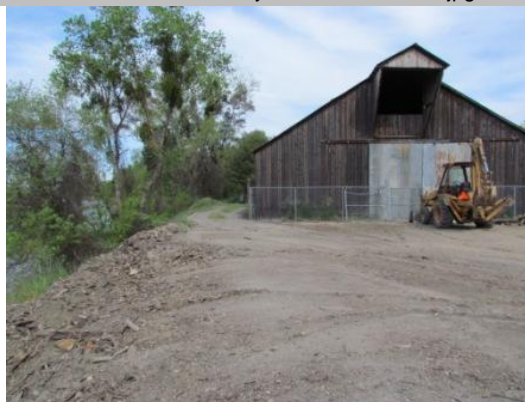
Photo 1 of 1 : rduffey_s_20140304_649.jpg

LM Start	4.66	Rating **	U	Issue No.	12
LM End	4.84	Issue Type +	En	Location *	CR
Category	Earthen Levee			GPS Latitude/Longitude	
				Start	End
Item	Encroachments			39.213265 °	39.213265 °
				-121.991672 °	-121.991672 °
DWR ID	DWR_ST0003_01 s _ 2012_12

View of the barn on the large crown of the levee.

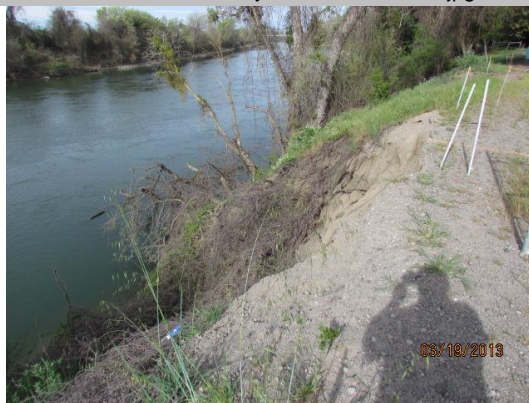
Photo 1 of 1 : rduffey_s_20140304_650.jpg

View of the erosion along the waterside slope.

LM Start	4.66	Rating **	M	Issue No.	15
LM End	4.66	Issue Type +	Ma	Location *	WS
Category	Earthen Levee			GPS Latitude/Longitude	
				Start	End
Item	Slope Stability			39.213271 °	39.213271 °
				-121.991676 °	-121.991676 °
DWR ID	DWR_ST0003_01_s _ 2013_15				
Action/Comments					
Repair slope instability.

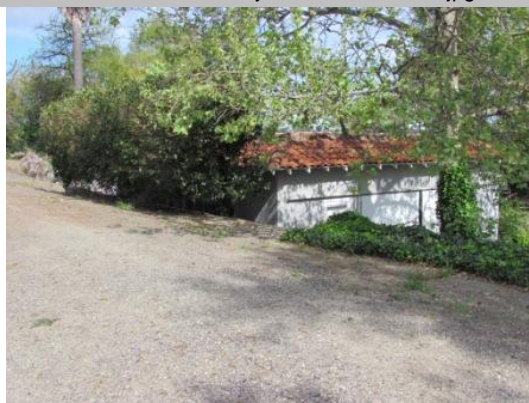
Photo 1 of 1 : rduffey_s_20140304_653.jpg

LM Start	4.81	Rating **	U	Issue No.	20
LM End	4.81	Issue Type +	En	Location *	LS
Category	Earthen Levee			GPS Latitude/Longitude	
				Start	End
Item	Encroachments			39.214168 °	39.214168 °
				-121.993515 °	-121.993515 °
DWR ID	DWR_ST0003_01_s _ 2012_20				
Action/Comments					
Building

View of the building next to the L/S toe.

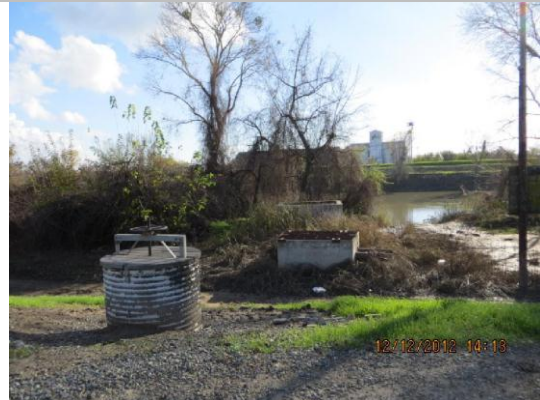
Photo 1 of 1 : UCIP_5121.jpg

LM Start	4.99	Rating **	M	Issue No.	39
LM End	4.99	Issue Type +	En	Location *	WS
Category	Supplemental			GPS Latitude/Longitude	
				Start	End
Item	DWR UCIP Field Study			39.214970 °	39.214970 °
				-121.997177 °	-121.997177 °
DWR ID	DWR_ST0003_01_s _ 2014_39				
Action/Comments					
Inspector Comments: FS_ID:26162					
EP_NO: 2904					
Repair Type:					
Crossing Status:					
UCIP Comments: Surge box on WS and distribution box across the county road on LS. Abandoned pump station and electrical panel on WS. A concrete pump pit on WS/29/2013 Portable tow-pump lowered down WS berm to water level and is pumping water into concrete surge box on WS and the filling the irrigation ditch on LS. Sink hole with standing water that is present above the outlet pipe for the WS surge box. This may indicate a leaking pipe or cracked concrete 12/30/2013 Sink Hole above pipe on WS still present. Pipe end inside of WS surge box shows heavy signs of rust and corrosion. Recommend having an internal camera inspection completed on pipe. FIELD_STRUCT_DESC: 36-inch corrugated metal pipe through the levee 18.4 feet below the crown. Slide gate in corrugate metal pipe riser on waterward shoulder, pump and concrete pump pit on the waterward bank. Concrete surge box on the waterward berm. Discharges into irrigation ditch on the opposite side of the county road. (App. No. 2904 - Arnold). Application was for an existing pumping system. O&M manual 136, revision May 2011.

Waterside view: CMP riser and surge box

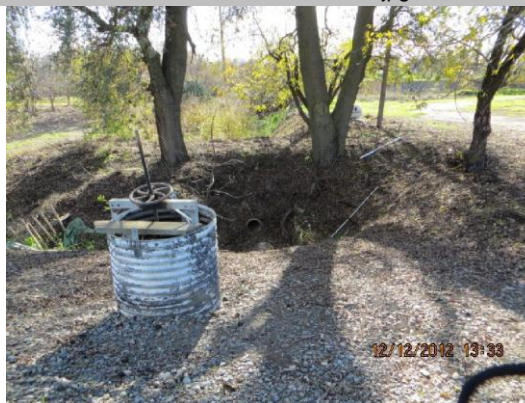
Photo 1 of 1 : UCIP_5133.jpg

Action/Comments					
Inspector Comments: FS_ID:26166					
EP_NO: 9514					
Repair Type:					
Crossing Status:					
UCIP Comments: - Water transfer ditch and CMP riser on WS/23/13 8inch pvc running through pipe preventing slide gate from closing. No positive pipe closure for high water season. Stem on WS screw gate is bent 2/18/2013 Same as last inspection. Levee inspections is working with land owner to solve this issue.					
FIELD_STRUCT_DESC: 24-inch corrugated metal pipe through the levee, slide gate in corrugated metal pipe riser. Concrete headwall on waterward berm, pump on riverbank. Discharges in field at landward toe. Irrigation ditch across waterward berm to headwall. (ABO No. 9514 - Boggs). Pipe invert 11.0 ft below crown. O&M manual 136, revision May 2011.					
FS Date: 1/2/2014 8:58:19 AM

Waterside view: CMP riser with slide gate

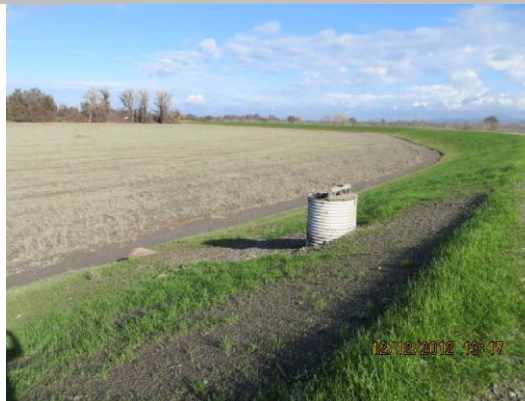
Photo 1 of 1 : UCIP_5146.jpg

LM Start	6.02	Rating **	M	Issue No.	41
LM End	6.02	Issue Type +	En	Location *	WS
Category	Supplemental			GPS Latitude/Longitude	
				Start	End
Item	DWR UCIP Field Study			39.220701 °	39.220701 °
				-122.002538 °	-122.002538 °
DWR ID	DWR_ST0003_01_s _ 2014_41				
Action/Comments					
Inspector Comments: FS_ID:26167					
EP_NO: 9514					
Repair Type:					
Crossing Status:					
UCIP Comments: 36-inch CMP found instead of 30-inch CMP. LS pipe tampered 7/23/2013 8inch PVC pipe ran through 36inch CMP preventing screw gate from closing for high water season 12/18/2013 Same as last inspection. Levee inspections is working with land owner to solve the issue.					
FIELD_STRUCT_DESC: 36-inch corrugated metal drainpipe through the levee 12.0 feet below the crown. Slide gate in corrugated metal pipe riser on the waterward slope. (ABO No. 9514 - Boggs). O&M manual 136, revision May 2011.					
FS Date: 1/2/2014 8:59:39 AM

Waterside view: overview

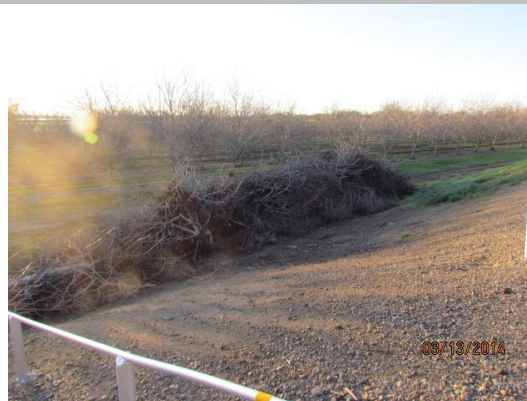
Photo 1 of 1 : rduffey_s_20140317_125.jpg

LM Start	6.33	Rating **	M	Issue No.	14
LM End	6.33	Issue Type +	Ma	Location *	LS
Category	Earthen Levee			GPS Latitude/Longitude	
				Start	End
Item	Encroachments			39.223540 °	39.223540 °
				-121.999028 °	-121.999028 °
DWR ID	DWR_ST0003_01_s _ 2012_14				
Action/Comments					
Prunings

View of the prunings along the landside toe.

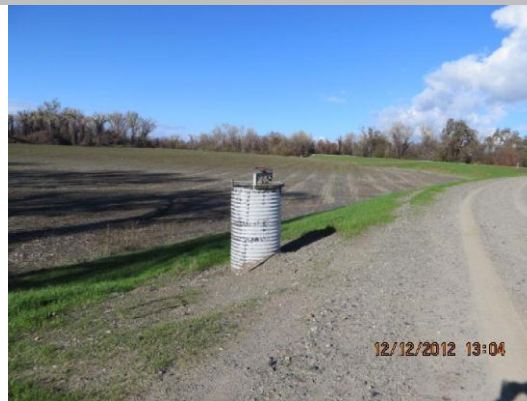
Photo 1 of 1 : UCIP_5155.jpg

LM Start	6.34	Rating **	M	Issue No.	42
LM End	6.34	Issue Type +	En	Location *	LS
Category	Supplemental			GPS Latitude/Longitude	
				Start	End
Item	DWR UCIP Field Study			39.223796 °	39.223796 °
				-121.999014 °	-121.999014 °
DWR ID	DWR_ST0003_01_s_2014_42				
Action/Comments					
Inspector Comments: FS_ID:26168					
EP_NO: 9530					
Repair Type:					
Crossing Status:					
UCIP Comments: Pipe outlet on WS partially burried, it needs cleaning7/23/2013 Same as last inspection12/18/2013 Same as last inspection.					
FIELD_STRUCT_DESC: 30-inch corrugated metal drainpipe through the levee 15.0 feet below the crown. Slide gate in corrugated metal pipe riser on the waterward slope. (ABO No. 9530 - Halsey).					
FS Date: 1/2/2014 9:00:48 AM

Waterside view: CMP riser with slide gate

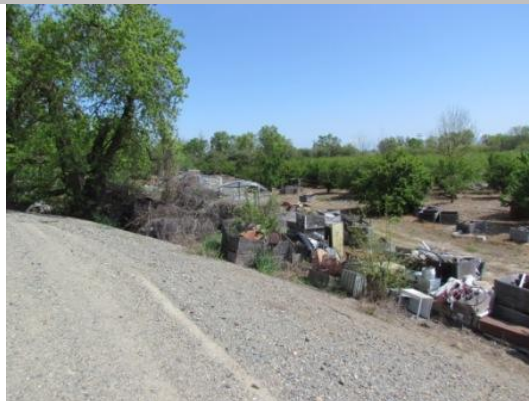
Photo 1 of 1 : rduffey_s_20140304_654.jpg

View of the material & garbage along the toe.

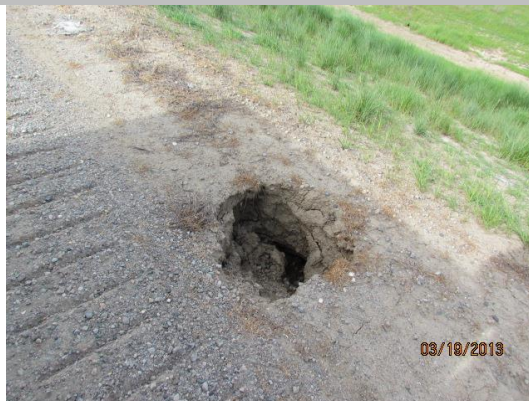
Photo 1 of 1 : rduffey_s_20140304_652.jpg

Erosion along the waterside crown.

LM Start	6.80	Rating **	M	Issue No.	19
LM End	6.80	Issue Type +	Ma	Location *	WS
Category	Earthen Levee			GPS Latitude/Longitude	
				Start	End
Item	Erosion / Bank Caving			39.228295 °	39.228295 °
				-121.998571 °	-121.998571 °
DWR ID	DWR_ST0003_01_s_2013_19				
Action/Comments					
Schedule repair of erosion site prior to the next inspection.

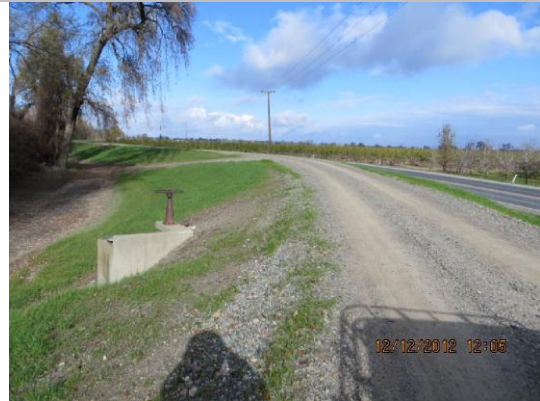
Photo 1 of 1 : UCIP_5159.jpg

LM Start	7.72	Rating **	M	Issue No.	43
LM End	7.72	Issue Type +	En	Location *	WS
Category	Supplemental			GPS Latitude/Longitude	
				Start	End
Item	DWR UCIP Field Study			39.239458 °	39.239458 °
				-121.993398 °	-121.993398 °
DWR ID	DWR_ST0003_01_s_2014_43				
Action/Comments					
Inspector Comments: FS_ID:26190					
EP_NO: 9532					
Repair Type:					
Crossing Status:					
UCIP Comments: Silted concrete box on WS. Depression/erosion around concrete box on WS/23/2013 Same as last inspection12/18/2013 Same as last inspection.					
FIELD_STRUCT_DESC: 3-foot by 4-foot concrete box culvert drain through the levee 11.6 feet below the crown. Slide gate in concrete box on the waterward slope. (ABO No. 9532 - Martin). O&M manual 136, revision May 2011.					
FS Date: 1/2/2014 9:35:14 AM

Waterside view: concrete box with slide gate

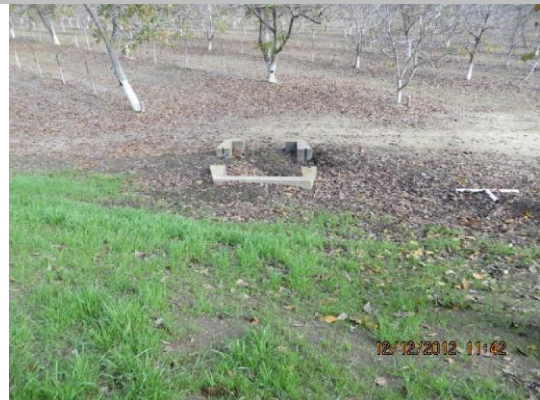
Photo 1 of 1 : UCIP_5162.jpg

LM Start	8.32	Rating **	M	Issue No.	44
LM End	8.32	Issue Type +	En	Location *	WS
Category	Supplemental			GPS Latitude/Longitude	
				Start	End
Item	DWR UCIP Field Study			39.246317 °	39.246317 °
				-121.998825 °	-121.998825 °
DWR ID	DWR_ST0003_01_s_2014_44				
Action/Comments					
Inspector Comments: FS_ID:26193					
EP_NO: 9529					
Repair Type:					
Crossing Status:					
UCIP Comments: Looks abandoned. CMP riser with slide gate on WS.					
Concrete distribution box on LS- full with silt/23/2013 Same as last inspection12/18/2013 Same as last inspection.					
FIELD_STRUCT_DESC: 24-inch corrugated metal pipe through the levee, slide gate CMP riser on the waterward slope. Concrete box at the landward toe. Pipe invert 12.8 ft below crown. (ABO No. 9529 - Dorwood Ranch)O&M manual 136, revision May 2011.					
FS Date: 1/2/2014 9:40:47 AM

Landside view: overview of concrete box

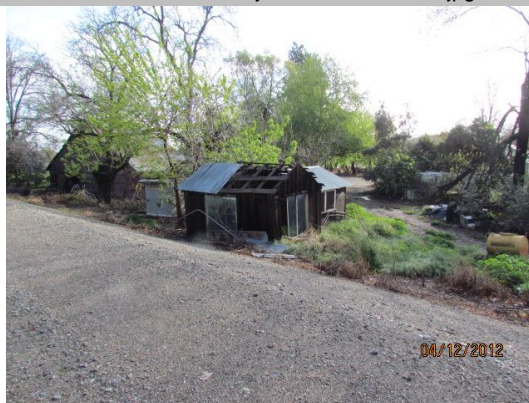
Photo 1 of 1 : rduffey_s_20140304_645.jpg

View of the building next to the toe of the levee.

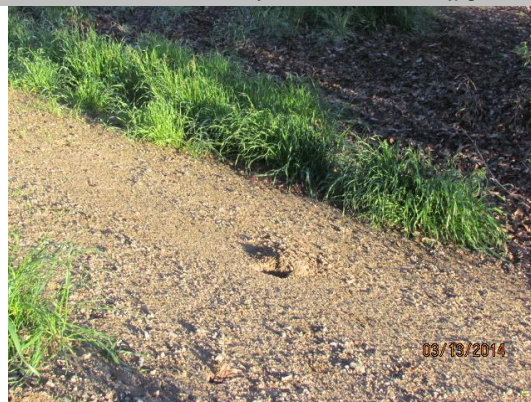
Photo 1 of 1 : rduffey_s_20140317_127.jpg

View of the active rodent hole along the landside slope.

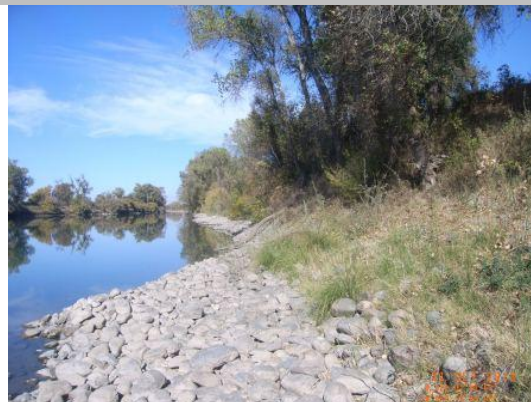
Photo 1 of 1 : USACE2013A_SAC_152-6_L_8.jpg

LM Start	11.51	Rating **	M	Issue No.	28
LM End	11.51	Issue Type +	Ma	Location *	WS
Category	Supplemental			GPS Latitude/Longitude	
				Start	End
Item	USACE Erosion Survey			39.279910 °	39.283853 °
				-122.018221 °	-122.016113 °
DWR ID					
Action/Comments					
Inspector Comments: 2008 - Large rotational/mass failure in the bank with tree slump. 2009 - Minimal new erosion, the tree is leaning further into the river. 2011 - Site extended downstream. 2012 - Minor new erosion and tree roots are further exposed. 2013: No observed changes. [2013 Site ID: SAC_152-6_L]

USACE 2013 Photo #1

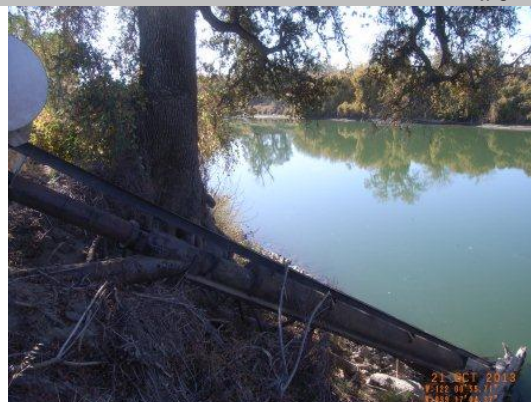
Photo 1 of 1 : USACE2013A_SAC_152-8_L_1.jpg

LM Start	11.83	Rating **	M	Issue No.	29
LM End	11.83	Issue Type +	Ma	Location *	WS
Category	Supplemental			GPS Latitude/Longitude	
				Start	End
Item	USACE Erosion Survey			39.284568 °	39.285298 °
				-122.015690 °	-122.015208 °
DWR ID					
Action/Comments					
Inspector Comments: 2006 - Large rotational/mass failure in the bank with tree slump. Tough clayey toe material. 2007 - Site is between stone revetments with a pump station at the downstream end. 2010 - Erosion is into the levee toe. 2011 - Minor new erosion. 2012 - Minor new erosion. 2013: No observed changes. [2013 Site ID: SAC_152-8_L]

USACE 2013 Photo #1

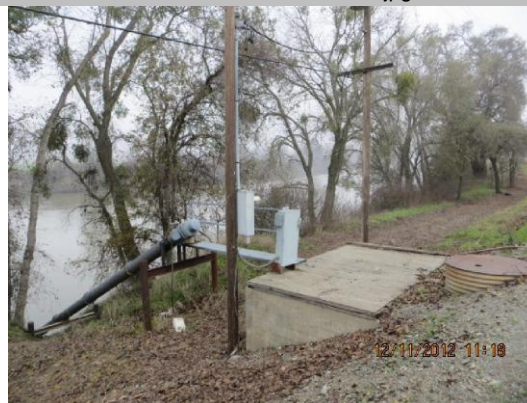
Photo 1 of 1 : UCIP_5167.jpg

Action/Comments					
Inspector Comments: FS_ID:26215					
EP_NO: 9514					
Repair Type:					
Crossing Status:					
UCIP Comments: Gate valve in CMP riser not visible. Flap gate in concrete distribution box on LS not visible/accessible. Looks cleaning required inside concrete surge tank on WS due to silting/29/2013					
Pump running and WS surge tank was full of water so not sure if silt was cleaned out. LS flap gate was visible and is in good condition 12/30/2013 Same as last inspection.					
FIELD_STRUCT_DESC: 36-inch corrugated metal pipe through the levee, 18.1 feet below the crown, pump house on the waterward slope. Gate valve in corrugated metal riser at waterward toe. Flap gate in concrete distribution box at the landward toe. (ABO No. 9514 - Boggs). O&M manual 136, revision May 2011.					
FS Date: 1/2/2014 1:35:53 PM

Waterside view: steel pipe, pump, surge box & CMP riser

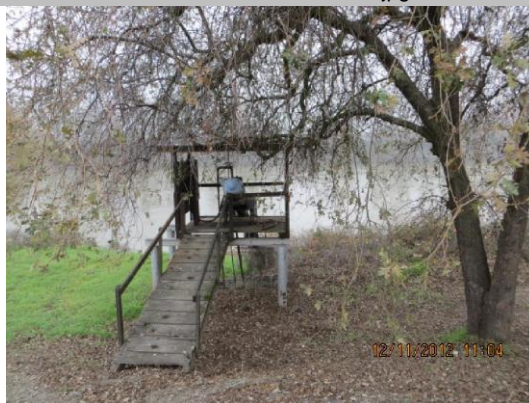
Photo 1 of 1 : UCIP_5175.jpg

UCIP Comments: A 2.5 inch GI pipe through 36 inch CMP found. A 2 inch electrical conduit also found 7/29/2013. 2.5in. GI pipe and chain in WS surge box will prevent slide gate from closing fully for high water season 12/30/2013 Same as last inspection.

Waterside view: overview of slanted pump and shed

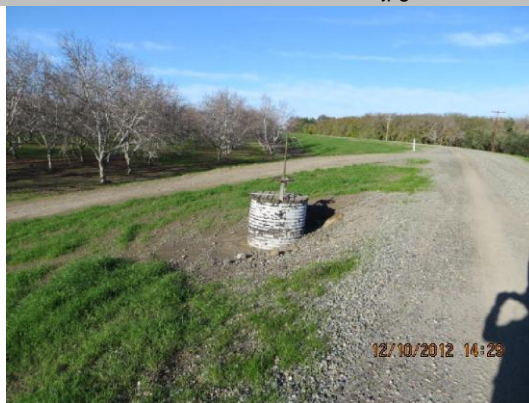
Photo 1 of 1 : UCIP_5186.jpg

LM Start	12.96	Rating **	M	Issue No.	47
LM End	12.96	Issue Type +	En	Location *	LS
Category	Supplemental			GPS Latitude/Longitude	
				Start	End
Item	DWR UCIP Field Study			39.300140 °	39.300140 °
				-122.013599 °	-122.013599 °
DWR ID	DWR_ST0003_01_s _ 2014_47				
Action/Comments					
Inspector Comments: FS_ID:26220					
EP_NO: 9510					
Repair Type:					
Crossing Status:					
UCIP Comments: Soil erosion around CMP riser and surge concrete box on WS damaged due to overflow. Pump not found. Flap gate missing on WS concrete box. WS slope eroded. Structure might have been used as drainage structure. This needs to be determined during routine inspection 7/23/2013. Water was flowing from the WS to LS ditch. Not sure where water flow was originating. All erosion problems are still present 12/19/2013. Same as last inspection.					
FIELD_STRUCT_DESC: 36-inch corrugated metal pipe through the levee, 18.0 feet below the crown. Slide gate in 36-inch corrugated metal riser on the waterward slope. Concrete box on the waterward side. Pump mounted on waterward bank. (ABO No. 9510 Forry). O&M manual 136, revision May 2011.

Waterside view: CMP riser on levee slope.

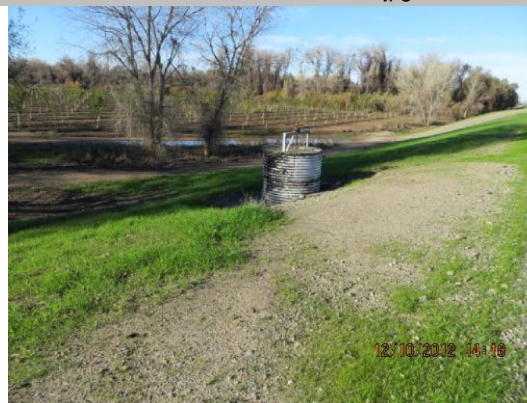
Photo 1 of 1 : UCIP_5193.jpg

DWR ID	DWR_ST0003_01_s _ 2014_48
Action/Comments	
Inspector Comments: FS_ID:26221	
EP_NO: N/A	
Repair Type:	
Crossing Status:	
UCIP Comments: Outlet pipe silted on WS. Inlet structure damaged on LS. Not properly abandoned 7/23/2013 Same as last inspection 12/19/2013 Same as last inspection.	
FIELD_STRUCT_DESC: Abandoned 48-inch corrugated metal drainpipe through the levee, 16.5 feet below the crown. Slide gate in 60-inch corrugated metal pipe riser on the waterward slope. Landward end of pipe on east side of River Road. O&M manual 136, revision May 2011.	
FS Date: 1/2/2014 1:48:59 PM

Waterside view: CMP riser with slide gate

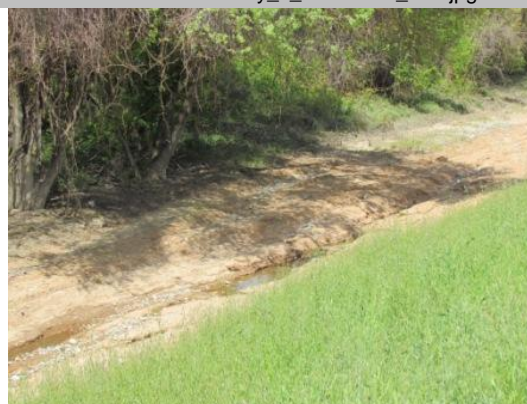
Photo 1 of 1 : rduffey_s_20140304_647.jpg

View of the erosion along the W/S toe.

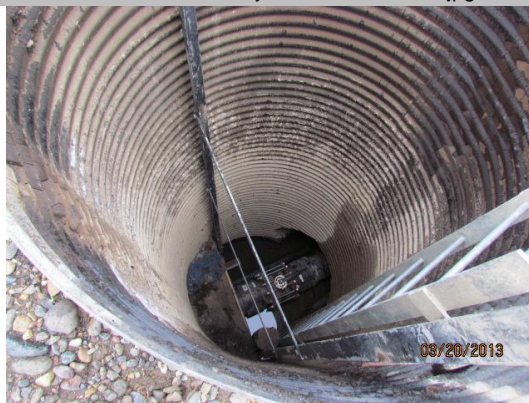
Photo 1 of 1 : rduffey_s_20140304_655.jpg

View of the unauthorized pipe placed inside the drain pipe.

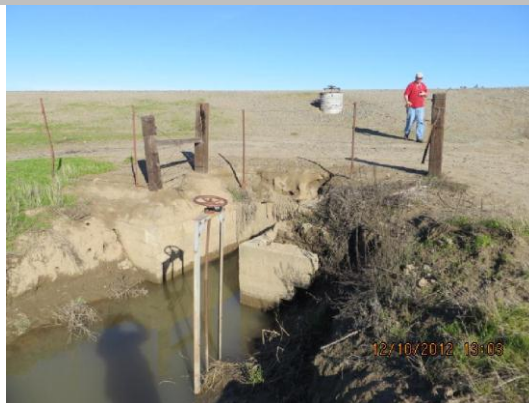
Photo 1 of 1 : UCIP_5203.jpg

Waterside view: water inlet /surge box

Inspector Comments: FS_ID:26227
EP_NO: 9506
Repair Type:
Crossing Status:
UCIP Comments: Water full on inlet and outlet of the structure 7/23/2013 Same as last inspection 12/19/2013 Same as last inspection.
FIELD_STRUCT_DESC: 24-inch pipe through the levee, 16.5 feet below crown. Pump in floodway. Irrigation transfer ditch on the waterward side to concrete surge box at the waterward toe. Slide gates in corrugated metal pipe riser on the waterward slope. Discharge into concrete distribution box at the landward toe. (ABO No. 9506 - Carter). O&M manual 136, revision May 2011.
FS Date: 1/2/2014 2:20:40 PM

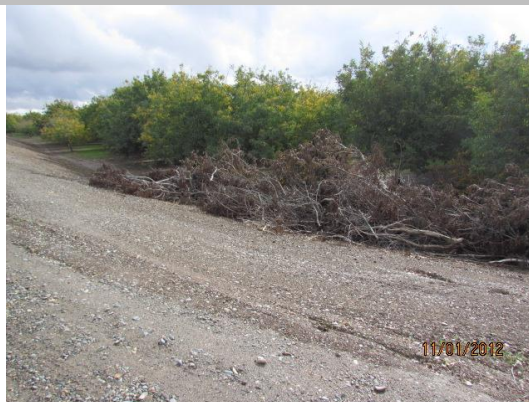
Photo 1 of 1 : rduffey_s_20140304_665.jpg

View of the brush pile along the landside toe.

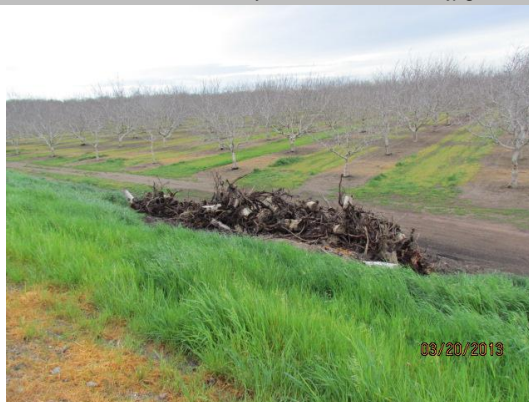
Photo 1 of 1 : rduffey_s_20140304_664.jpg

View of the walnut orchard stumps along the landside toe.

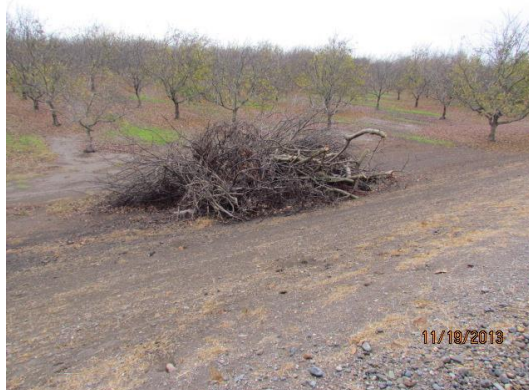
Photo 1 of 1 : rduffey_s_20140304_666.jpg

View of the prunings at the toe of the levee.

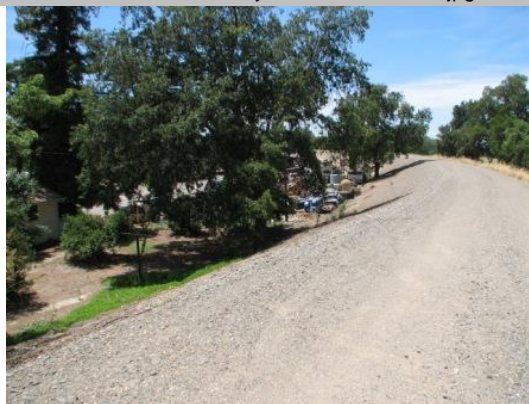
Photo 1 of 1 : rduffey_s_20140304_651.jpg

View of the equipment and trees next to the landside toe of the levee.

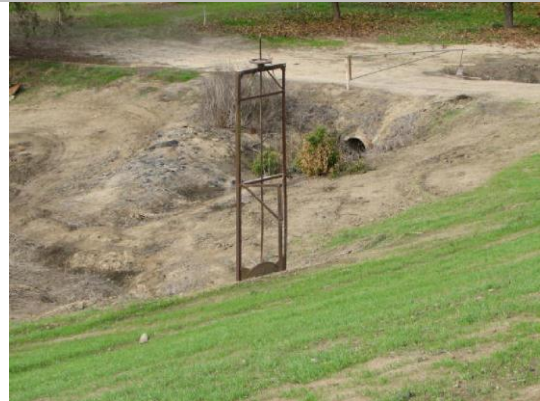
Photo 1 of 1 : UCIP_5205.jpg

LM Start	18.65	Rating **	M	Issue No.	50
LM End	18.65	Issue Type +	En	Location *	LS
Category	Supplemental			GPS Latitude/Longitude	
				Start	End
Item	DWR UCIP Field Study			39.362866 °	39.362866 °
				-121.997993 °	-121.997993 °
DWR ID	DWR_ST0003_01_s _ 2014_50				
Action/Comments					
Inspector Comments: FS_ID:26240					
EP_NO: N/A					
Repair Type:					
Crossing Status:					
UCIP Comments: It is not an abandoned crossing. Sloughing at outlet and levee slope is damaged due to sloughing 7/24/2013 Same as last inspection 12/19/2013 Same as last inspection.					
FIELD_STRUCT_DESC: A 36- inch corrugated metal drainpipe through the levee, 20.0 feet below the crown. Slide gate at the waterward toe.					
O&M manual 136, revision May 2011.					
FS Date: 1/2/2014 3:05:54 PM

Waterside view: overview of sliding gate structure

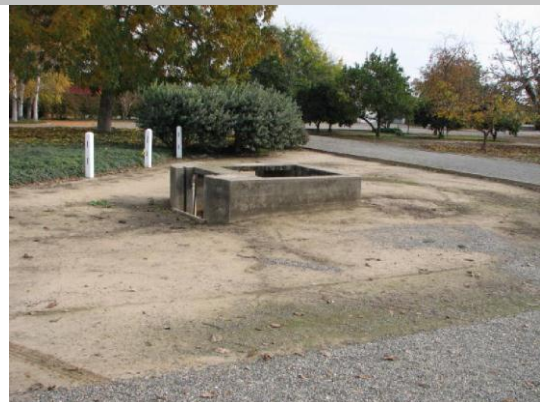
Photo 1 of 1 : UCIP_5217.jpg

LM Start	18.74	Rating **	M	Issue No.	51
LM End	18.74	Issue Type +	En	Location *	LS
Category	Supplemental			GPS Latitude/Longitude	
				Start	End
Item	DWR UCIP Field Study			39.364067 °	39.364067 °
				-121.997792 °	-121.997792 °
DWR ID	DWR_ST0003_01_s _ 2014_51				
Action/Comments					
Inspector Comments: FS_ID:26263					
EP_NO: N/A					
Repair Type:					
Crossing Status:					
UCIP Comments: According to local people, the crossing is functional.					
The gap between 8-inch and 24-inch pipes is grouted with cement. Inlet					
structure is filled with soil 7/24/2013 Same as last					
inspection 12/19/2013 Same as last inspection.					
FIELD_STRUCT_DESC: A 8-inch steel pipe sleeved into 24- inch					
corrugated metal drain pipe through the levee, 19.0 feet below the					
crown. Slide gate at waterward toe and concrete inlet box on landside					
of the levee. O&M manual 136, revision May 2011.					
FS Date: 1/3/2014 6:54:53 AM

Landside view: overview of inlet structure

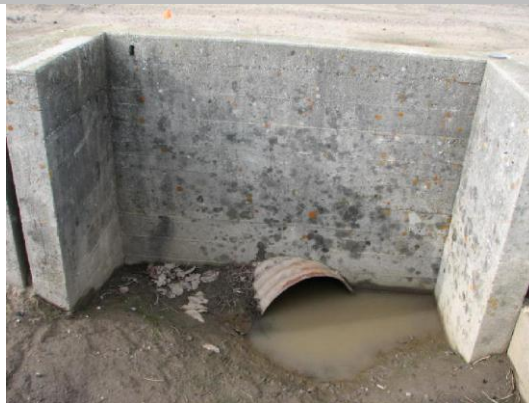
Photo 1 of 1 : UCIP_5225.jpg

UCIP Comments: Slide Gate WS not found. An abandoned pump and steel pipe found on WS. A 6 ft x 8 ft concrete distribution box with a CMP found on LS. Box filled with soil. An abandoned crossing 7/24/2013 Same as last inspection 12/19/2013 Same as last inspection.

Landside view: concrete distribution box and pipe

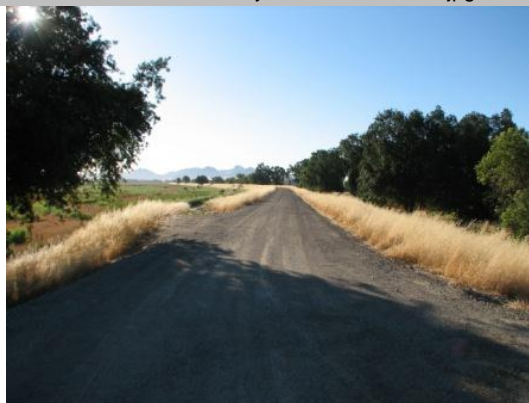
Photo 1 of 1 : rduffey_s_20140304_667.jpg

View of the elderberries along the landside toe of the levee.

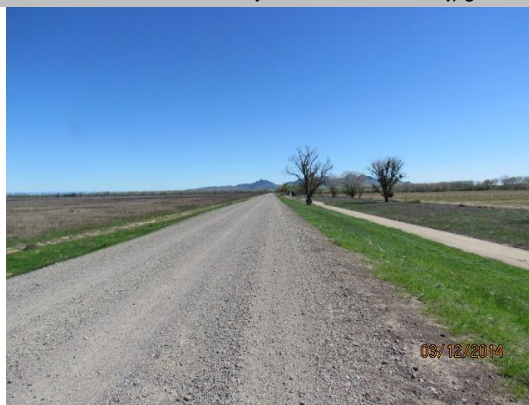
Photo 1 of 1 : rduffey_s_20140317_123.jpg

View of the native grasses on both slopes.

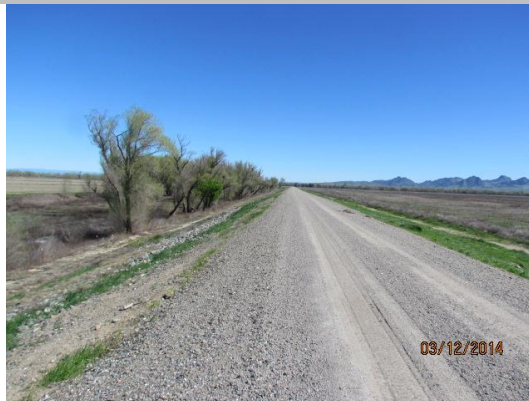
Photo 1 of 1 : rduffey_s_20140317_124.jpg

View of the native grasses on both slopes.

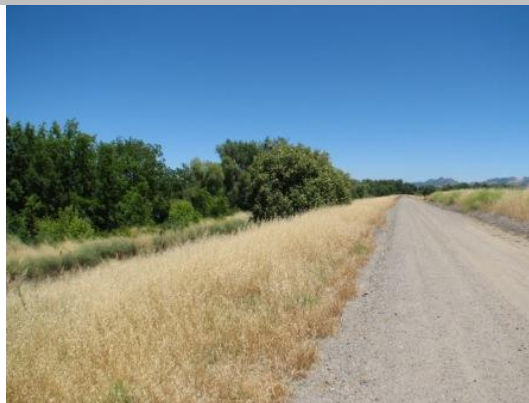
Photo 1 of 1 : rduffey_s_20140304_668.jpg

View of the elderberries along the landside toe of the levee.

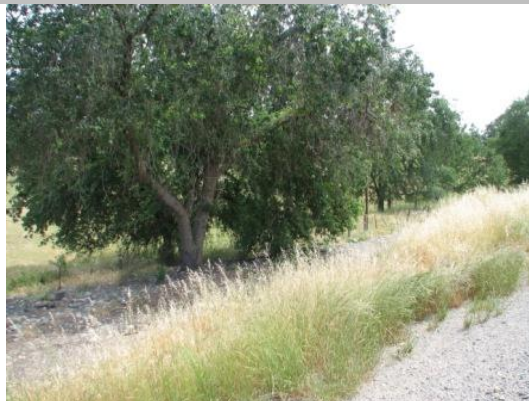
Photo 1 of 1 : rduffey_s_20140304_669.jpg

View of an elderberry bush by the waterside toe.

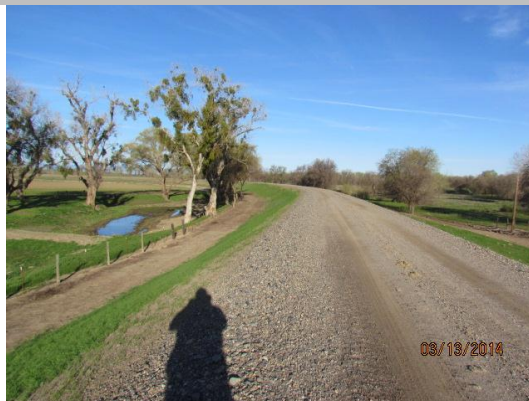
Photo 1 of 1 : rduffey_s_20140317_128.jpg

View of the native grasses on both slopes.

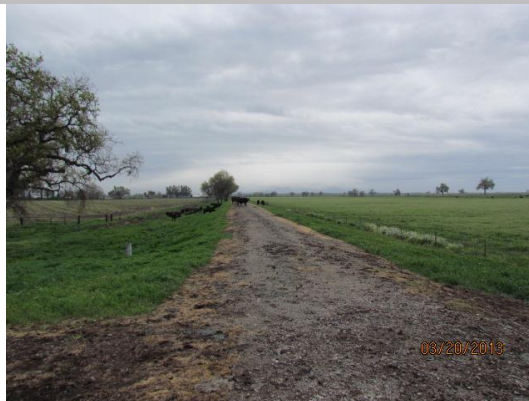
Photo 1 of 1 : rduffey_s_20140304_670.jpg

View of the damage to the levee caused by the landowners livestock on both slopes.

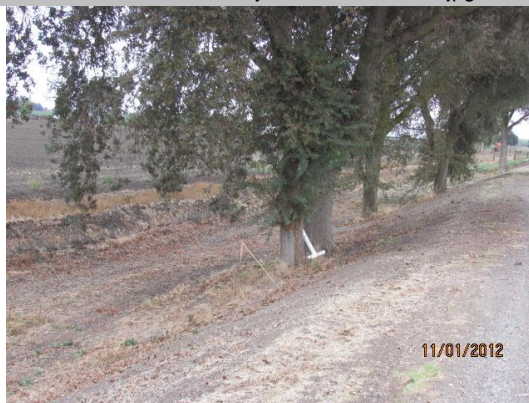
Photo 1 of 1 : rduffey_s_20140304_671.jpg

View of the repaired rodent holes and bait station along the landside slope.

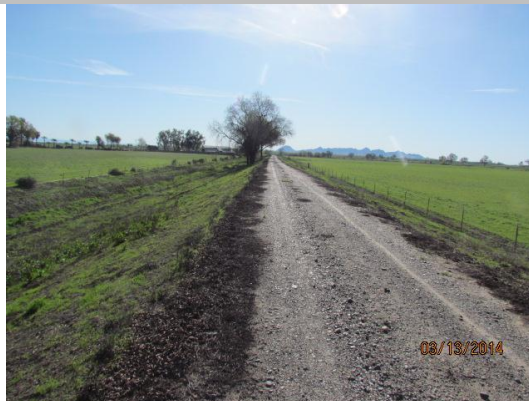
Photo 1 of 1 : rduffey_s_20140317_129.jpg

View of the native grasses on both slopes.
